Manhole Inspection Summary

Manhole # S65S__011MH

Insp Date: **3/6/08 10:37 AM**

Location Address: **6200 Danville Ave.**

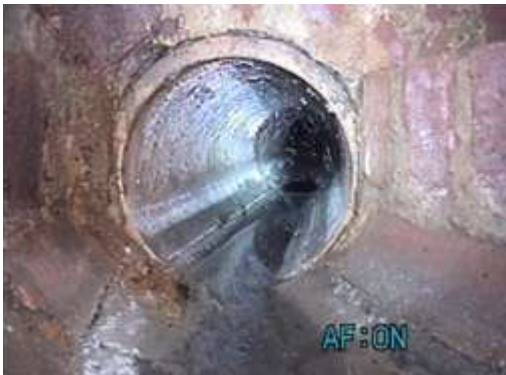
Defect 3

Cracked pipe seal 10:00-2:00 incoming 9 O'Clock pipe

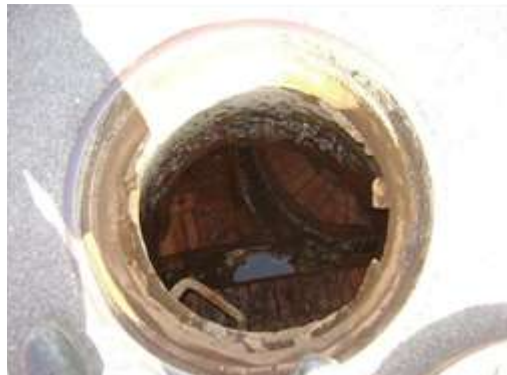
Offset: **2** (in.)

Frame offset defect

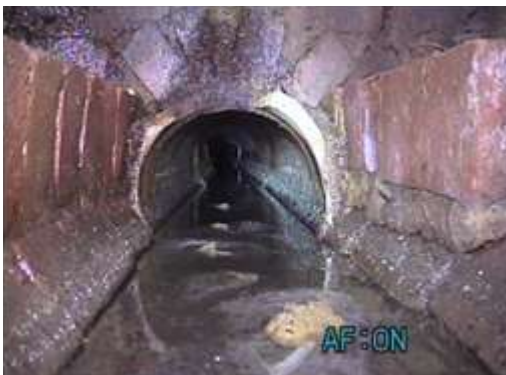
Defect 2

Condition: ☐ Sound ☐ Cracked ☐ Root Intrusion ☐ Loose Brick ☒ **Deteriorated**

Infiltration: ☐ None ☐ Joint ☐ Cracks ☐ Mortar ☐ Roots ☒ **Wall**

Infiltration in barrel. at 12:00 above pipe. Incoming 6 O'Clock

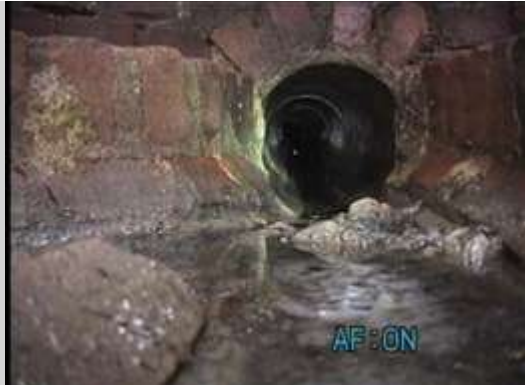
12 O'Clock Outflow

8 in. Circular Gravity Sewer
Pipe Out @ 12 O'Clock

Pipe Height: **8.4** (in.) Rod and Bar (Angled)
Pipe Material: **Clay** ☐ Pipe Lined
Invert Depth: **7.38** (ft.) Flow Characteristics: **Slow**
Deposits: ☒ None ☐ Mud ☐ Sludge ☐ Debris ☐ Grease
Silt Depth: (in.) Deposits Extent:
Infiltration: **None** Pipe Seal Cond: **Sound**

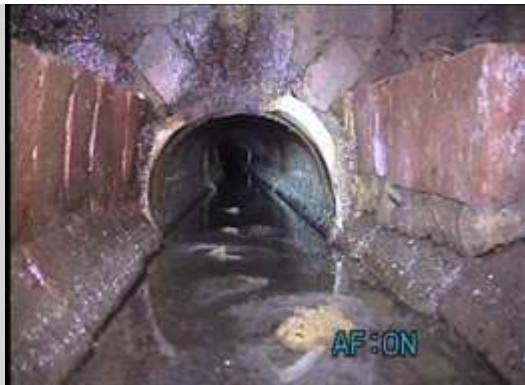
6 O'Clock Inflow

8 in. Circular Gravity Sewer
Pipe In @ 6 O'Clock

Pipe Height: **8.4** (in.) Rod and Bar (Angled)
Pipe Material: **Clay** ☐ Pipe Lined
Invert Depth: **7.42** (ft.) Flow Characteristics: **Slow**
Deposits: ☒ None ☐ Mud ☐ Sludge ☐ Debris ☐ Grease
Silt Depth: (in.) Deposits Extent:
Infiltration: **None** Pipe Seal Cond: **Sound**

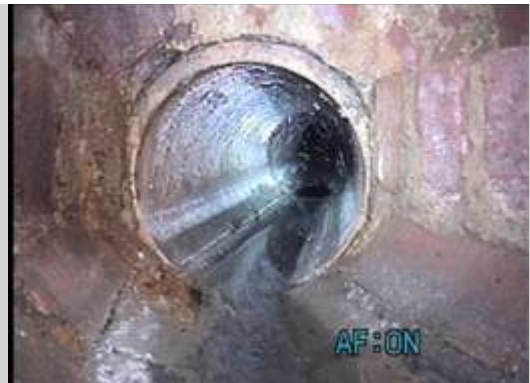
9 O'Clock Inflow

Invert Depth: **7.33** (ft.) Flow Characteristics: **None**

Infiltration: **Evidence** Pipe Seal Cond: **Cracked**
